FLOOD PROOFING TESTS

Tests of Materials and
Systems for Flood
Proofing Structures

August 1988

US Army Corps of Engineers

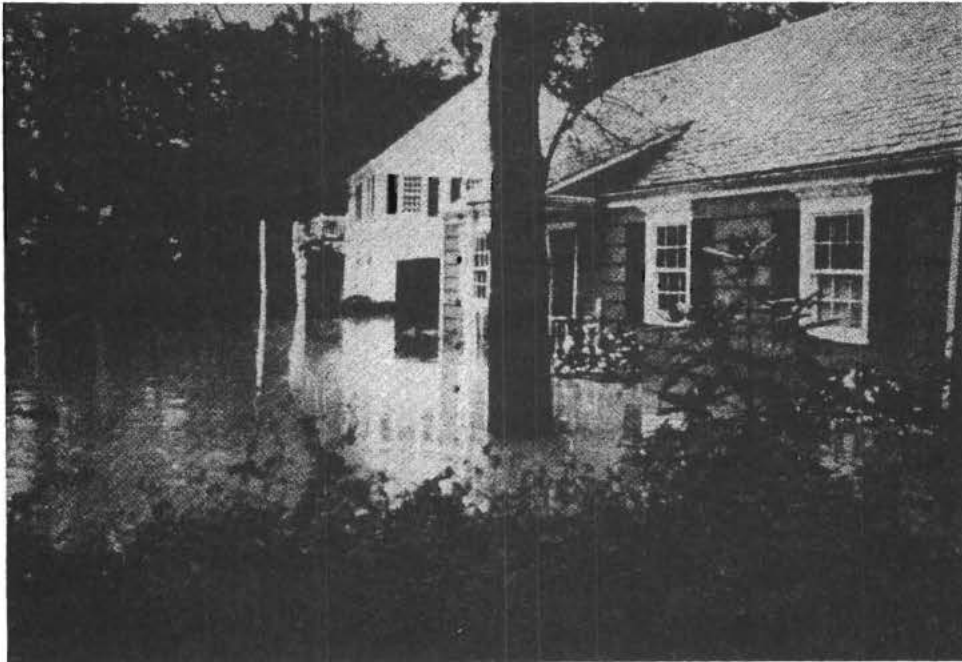
Despite the construction of flood control projects and the development of public programs to reduce flood losses, flood damage to homes and other buildings in the United States has increased dramatically (Figure 1 is an example of a flooded home). The growing exposure of structures to flooding is largely due to rising land costs and a reduction in the quantity of available land for building, thus resulting in an encroachment on flood plains.

Figure 1. Example of a flooded home

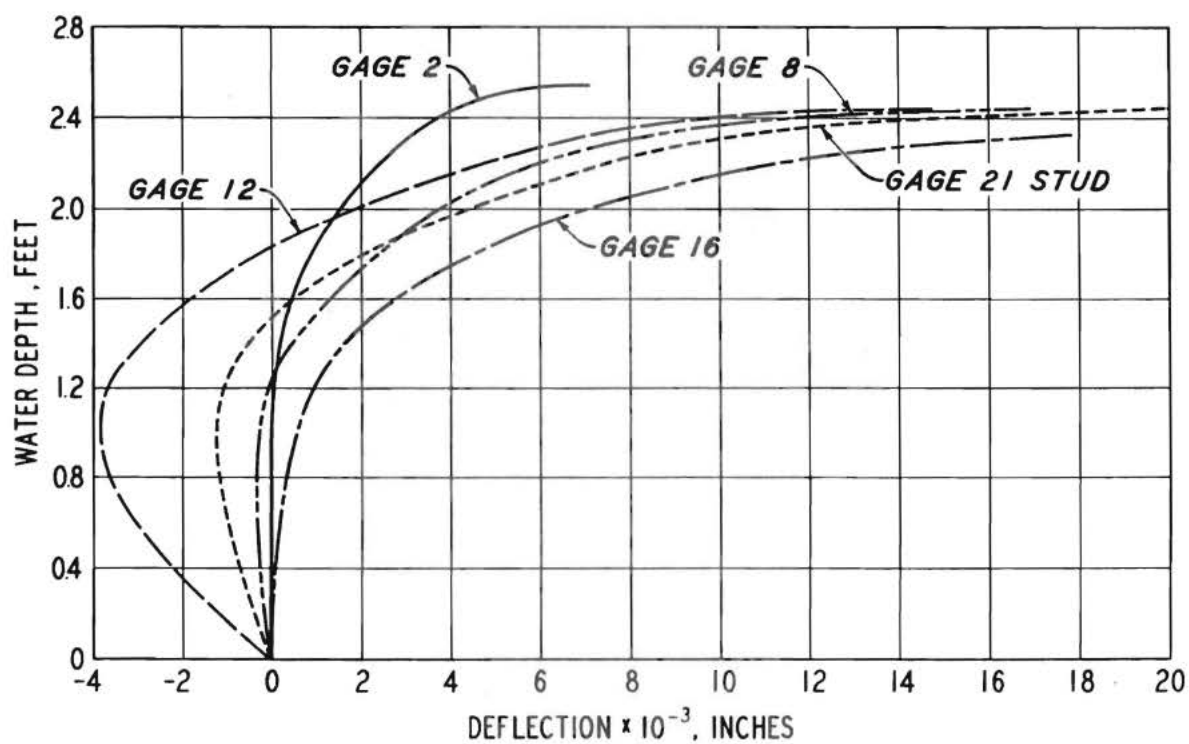
A severe loss of integrity began at 2 ft of water with complete loss occurring at 2.4 ft (Figure 8). The failure at 2.4 ft of water is presented in Figures 10 and 11.

Figure 8. Wall 1. Brick-veneer wall and stud deflections, vertical gage line

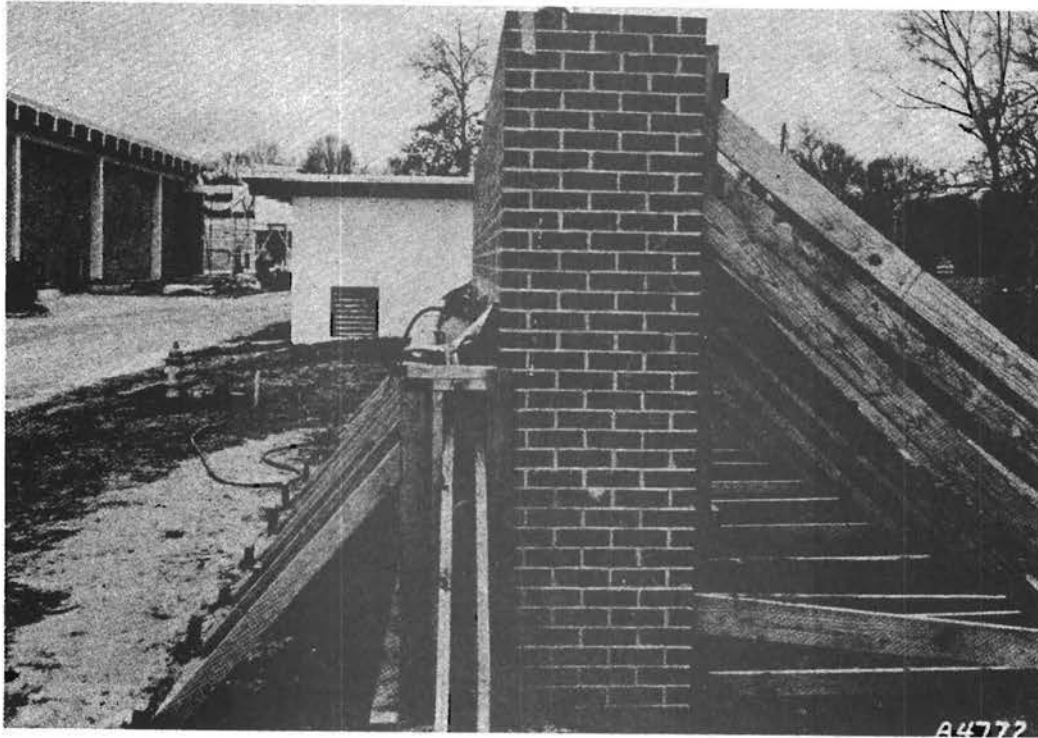
Figure 9. Wall 1. Wall deflection

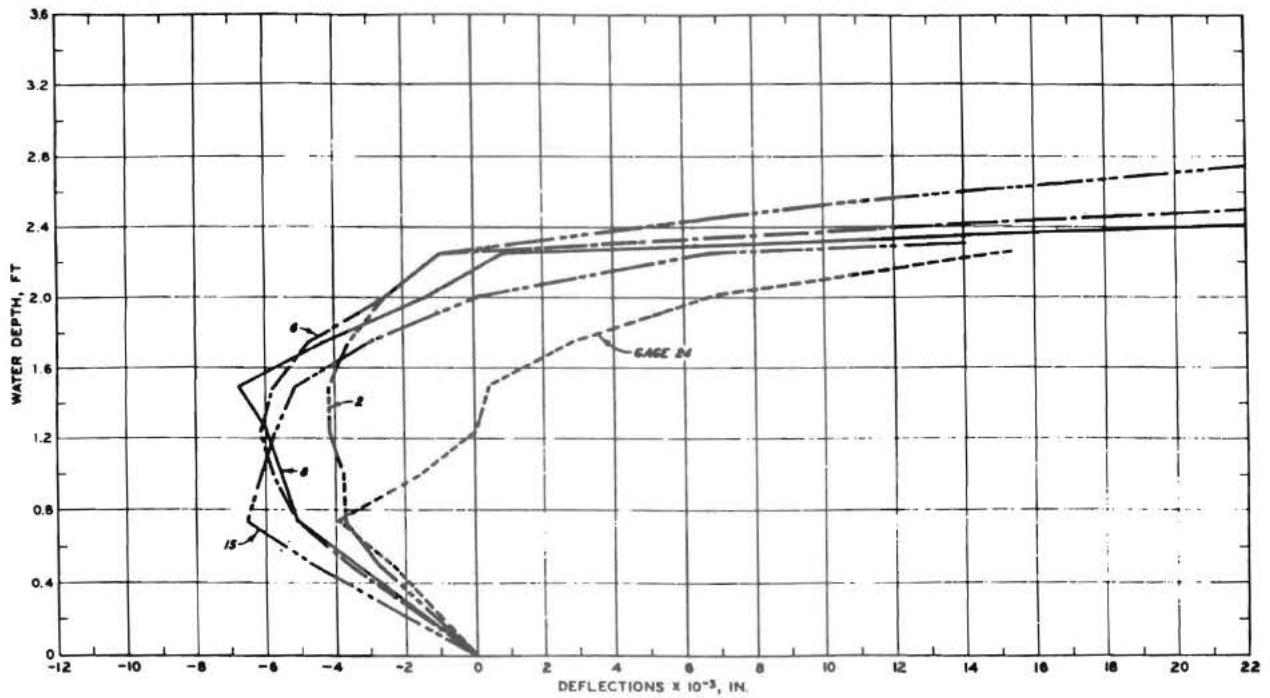
Figure 12. Wall 2. Brick-veneer wall deflections, vertical gage line, initial loading

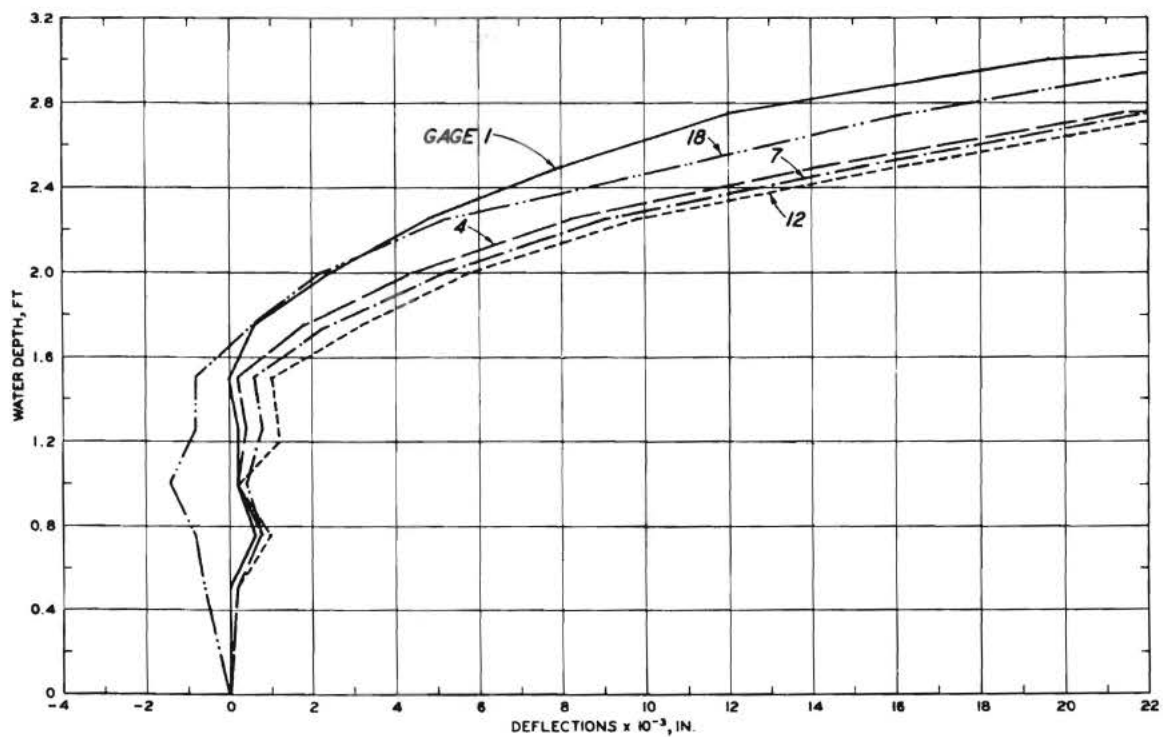
Figure 15. Wall 3. Brick-veneer wall deflection, vertical gage line

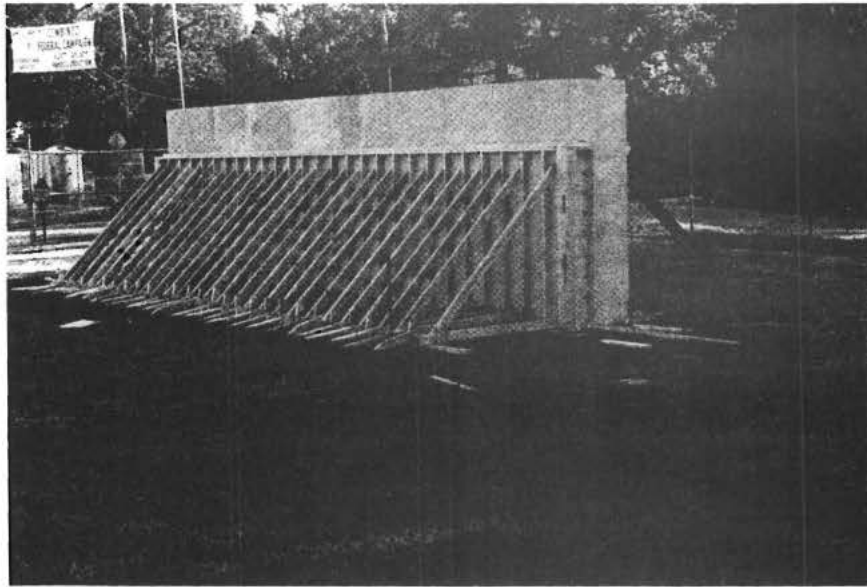
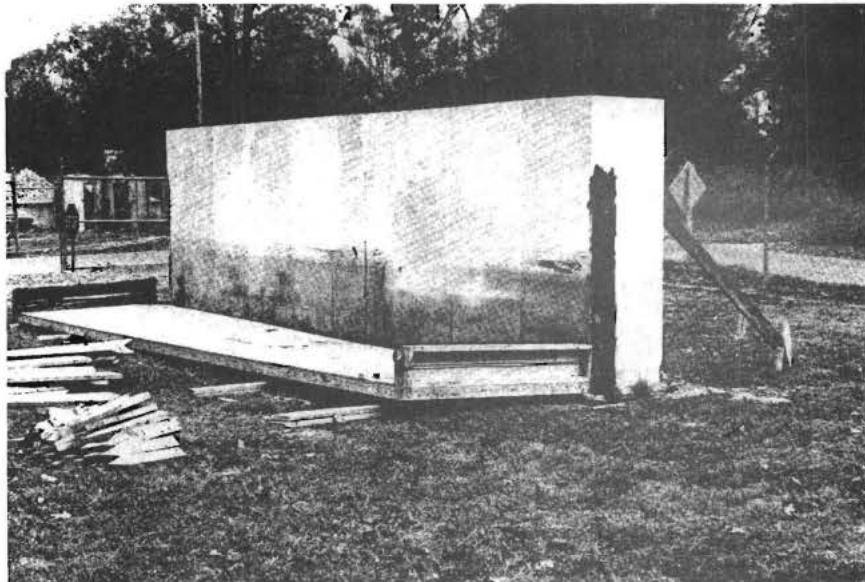
Figure 18. Block Wall 1

Block Wall 1, before and after the testing, is shown in Figure 18. The front of the first wall was plastered, and a bulkhead was constructed in front of it to contain water to be supplied from a fire hydrant. The second block wall is shown in Figure 19. Block Wall 2 was used to test several flood protection systems.

a. Before testing

b. After testing

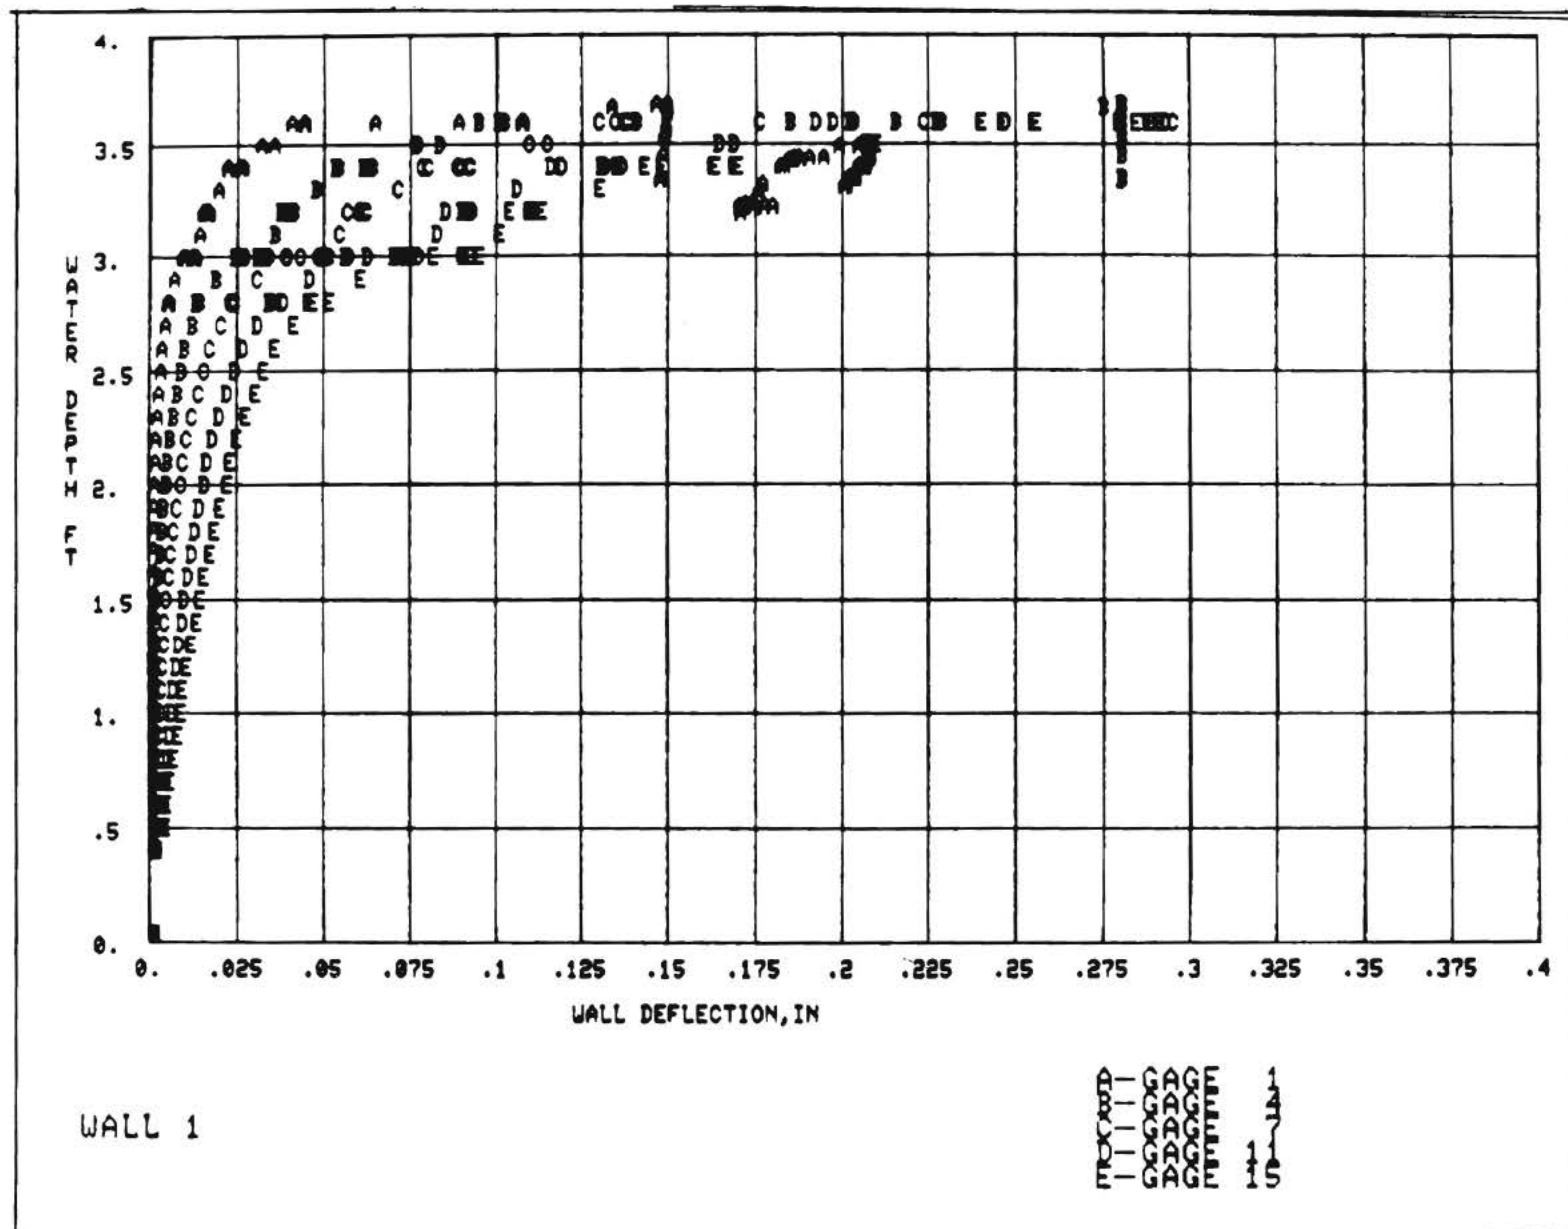
Typical deflection data for Block Wall 1 are presented in Figure 20. As the water level was raised against the surfaced wall, the plaster was weakened and was penetrated by the water; thereby reducing its effectiveness in strengthening the wall against deflection. At a water depth of 3-1/2 ft the block wall was cracked and leaking so badly that the trough could not be kept filled with water from a fire hose connected to the fire hydrant. Water flowed through the cracks faster than it could be put into the trough. Photographs of the leakage are shown in Figure 21.

Figure 20. Wall 1. Water depth versus deflection, gages 1, 4, 7, 11, and 15

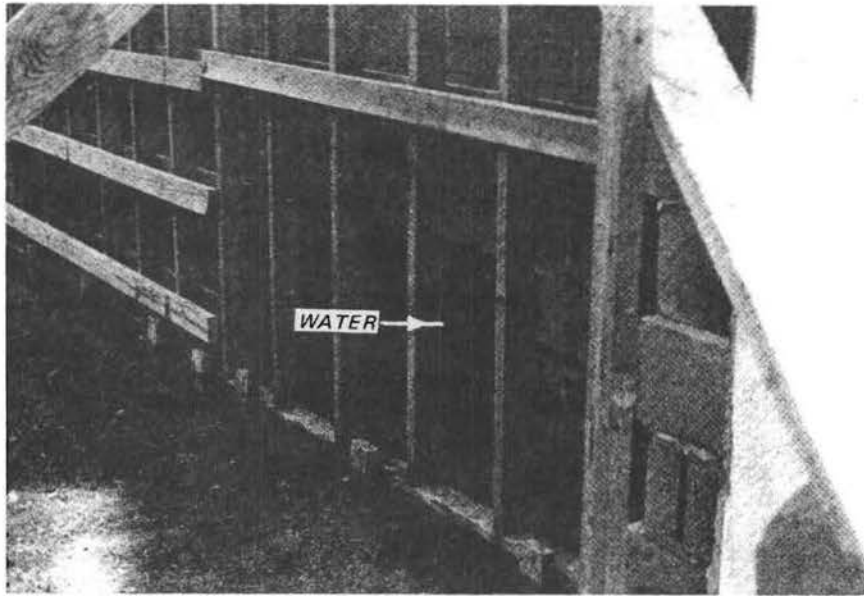
Figure 21. Leakage through block wall

a. Stream of water coming through wall

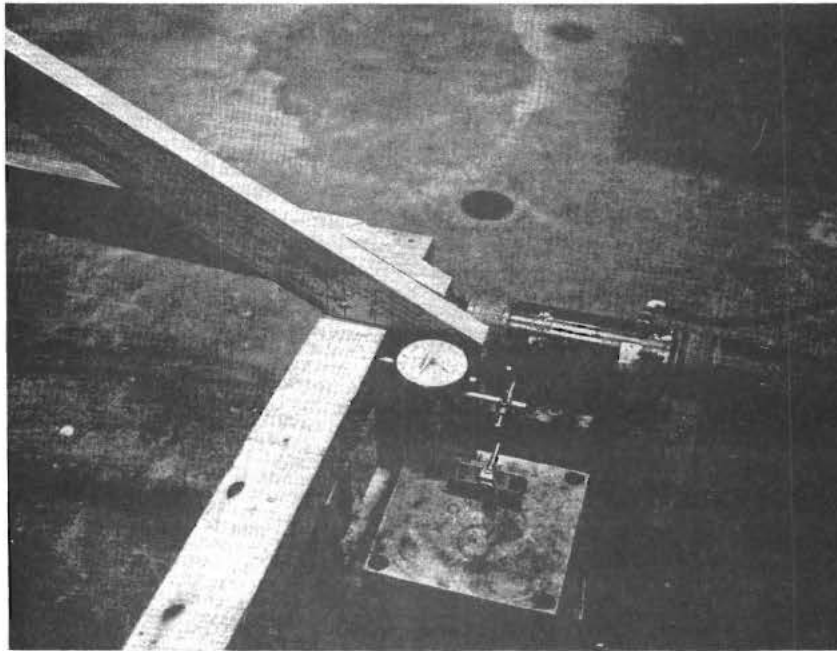
A test setup for roof rafter and ceiling joist restraints is presented in Figure 22.

Figure 22. Nailed roof rafter and ceiling joist connection (connection has been failed)

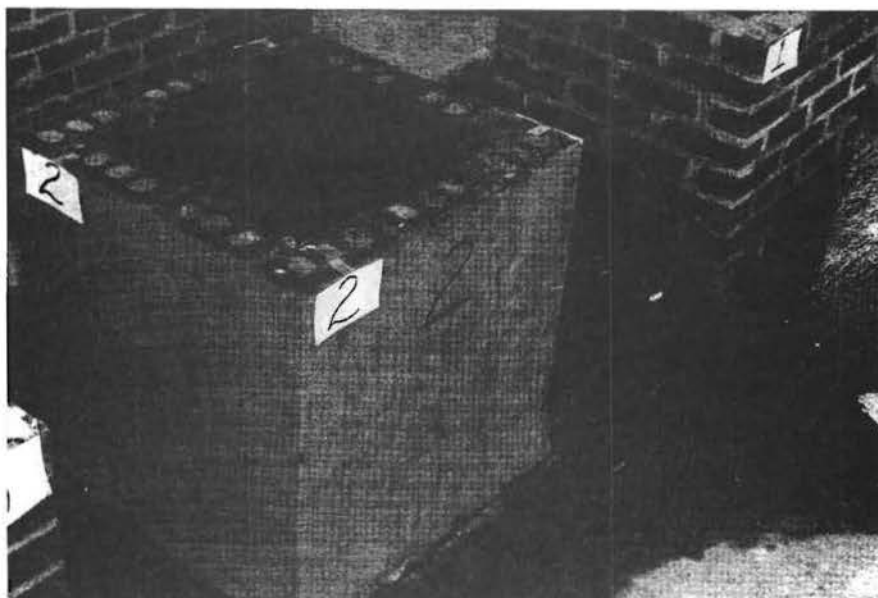
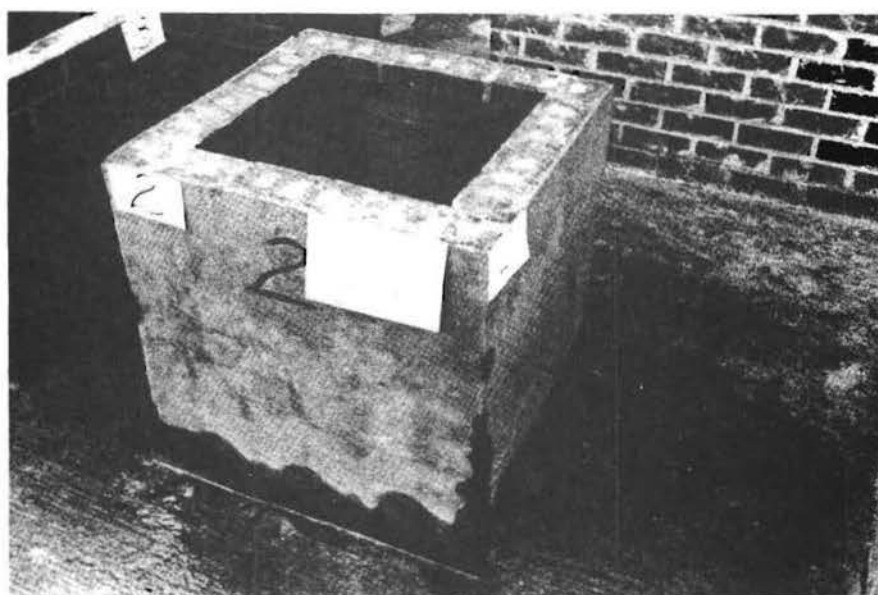
Figure 45. Initial testing of coating 4

a. Two hours after cube was filled with water

b. One day after cube was filled with water

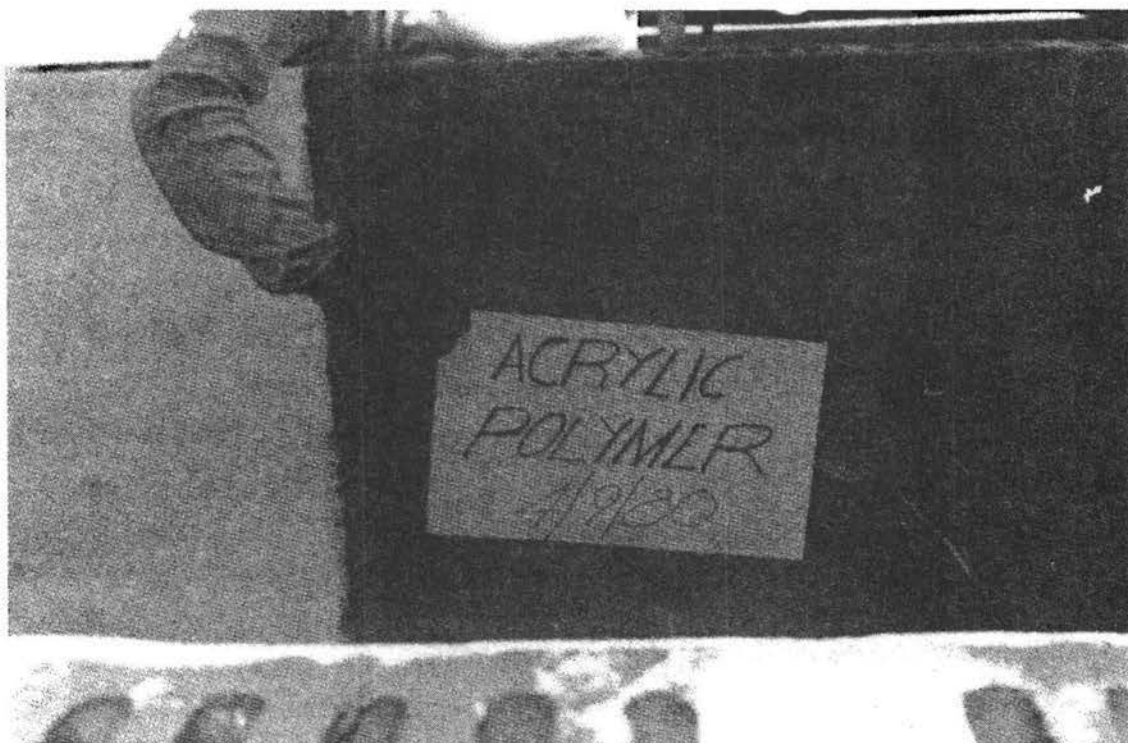
Figure 47. Coating 5

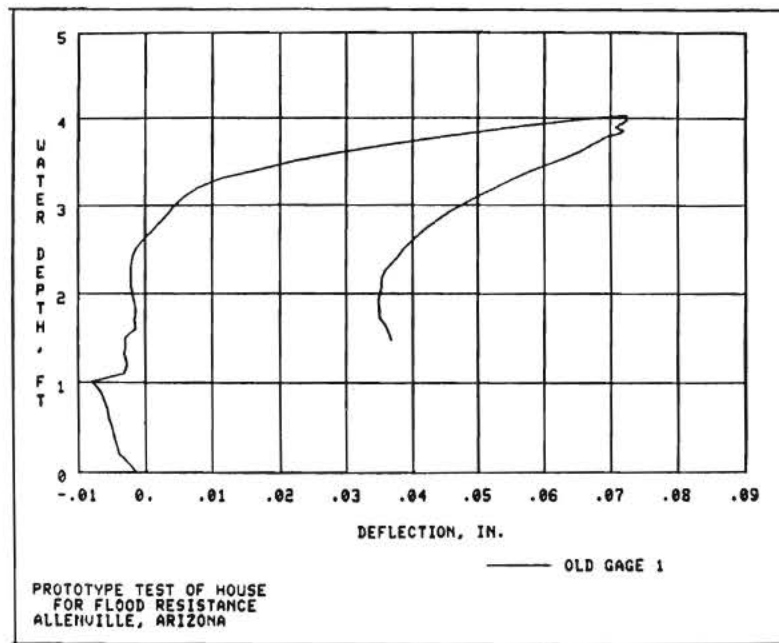
The deflections of the walls were recorded during both the loading and unloading of the house. Typical data are presented in Figure 61.

The walls of the house were damaged by a 4-ft waterhead. This damage is indicated by the test data in Figure 61. The unloading curves show permanent deformation in the walls. An inspection the next morning after the water load had been removed revealed that the brick wall had visual cracks in the mortar joints.

Figure 61. Prototype house test results, gage 1
